# Situation Photo Log

Friday, September 7, 2012

Kalamazoo River / Enbridge Spill

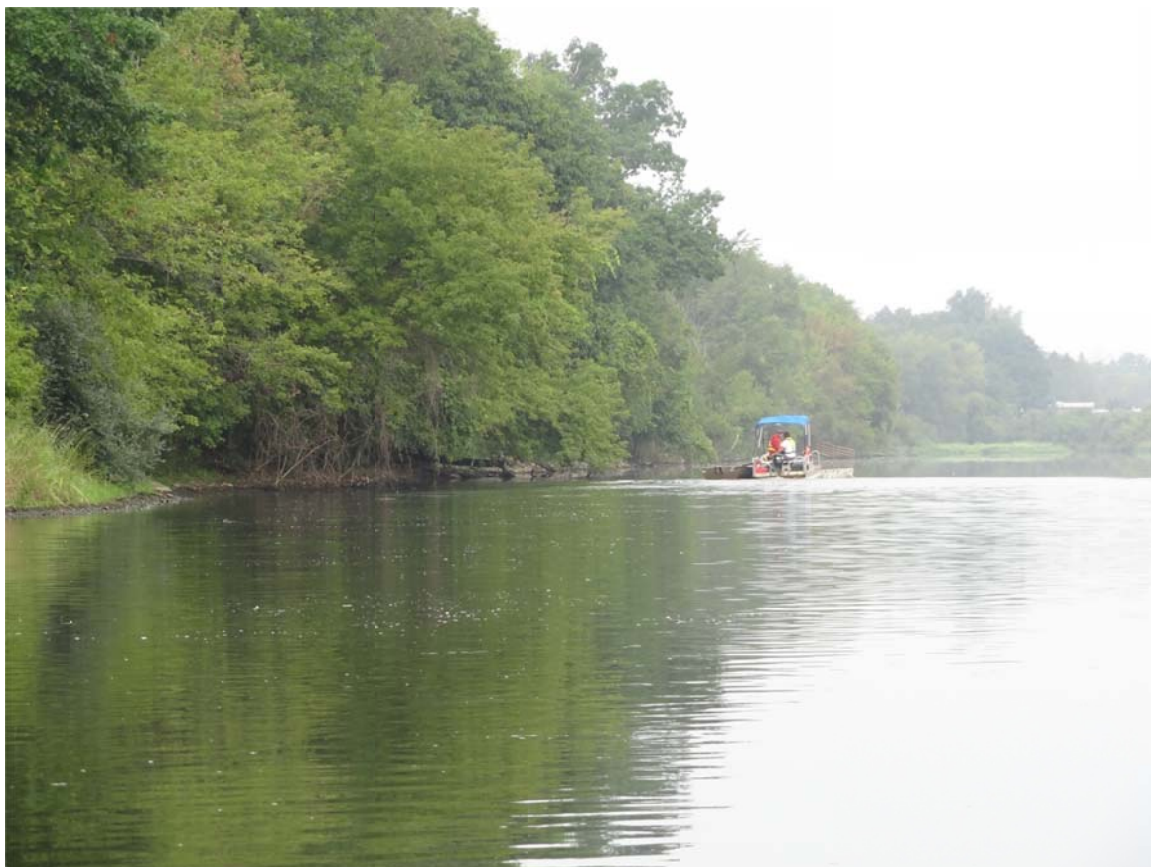
1. Sheen sweeper boat operating near MP 5.5 LDB.

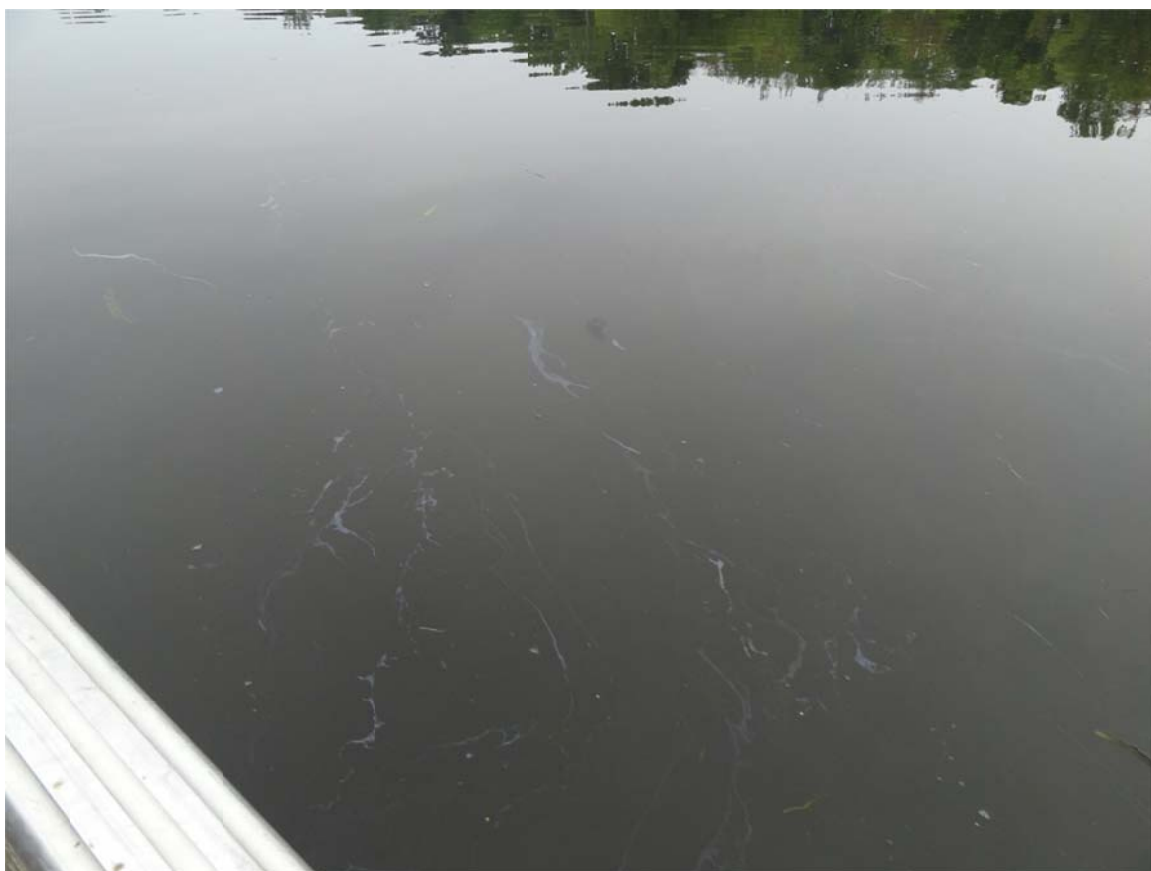
2. Sheen and tar globules observed near MP 5.5 LDB above Ceresco Dam.

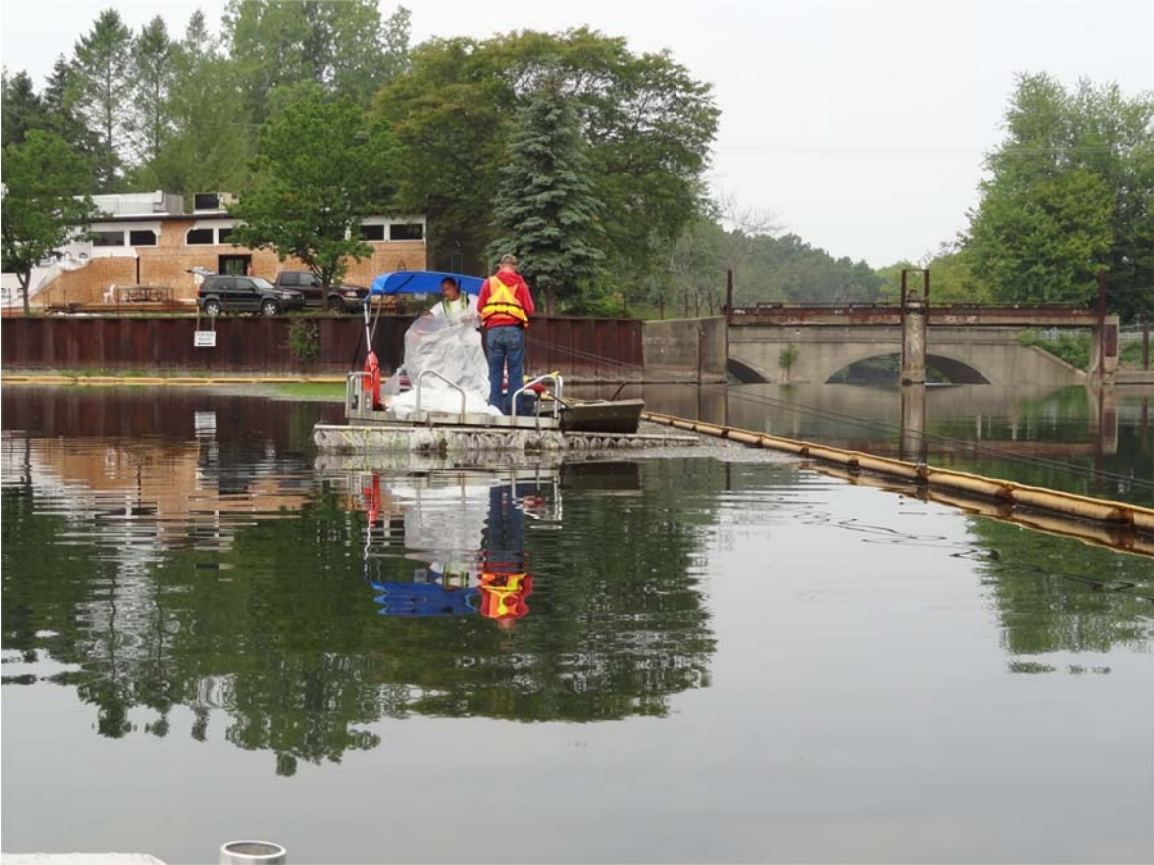
3. Vegetation removal from containment point above Ceresco Dam.

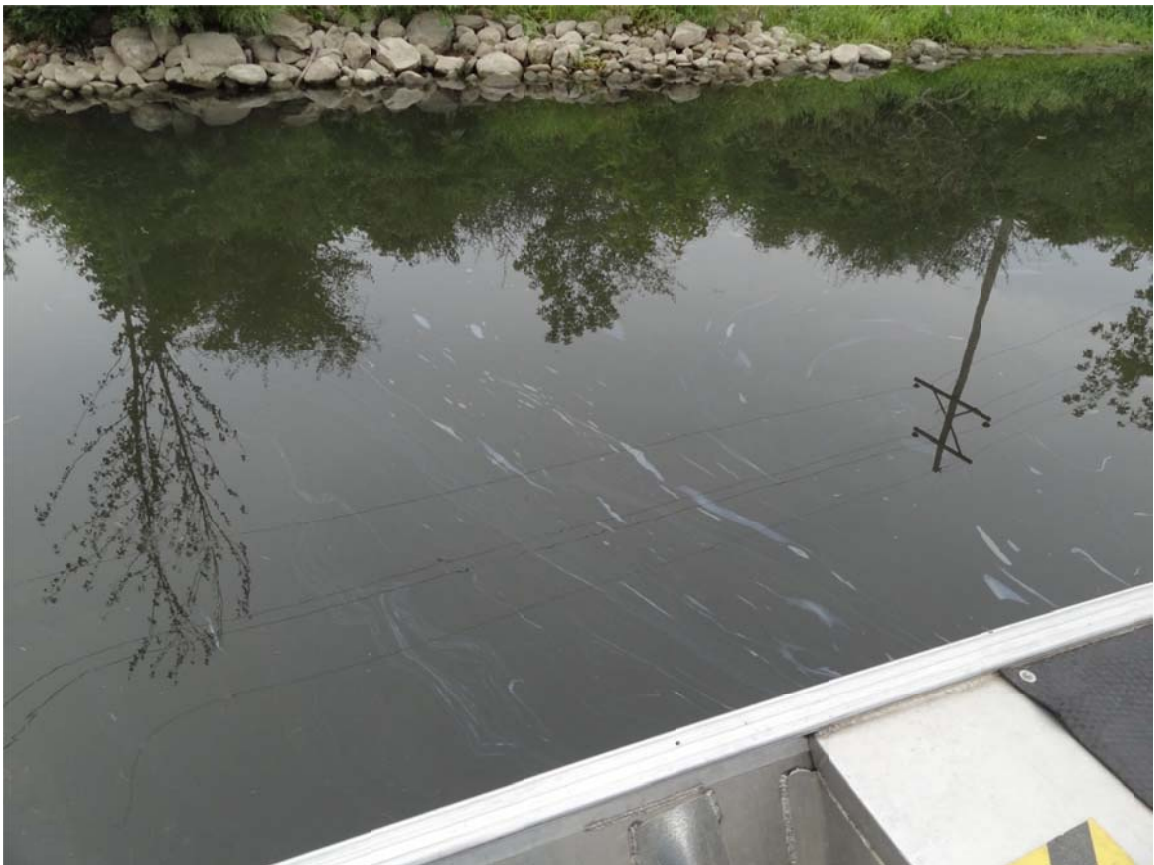
4. Sheen and tar globules observed along MP 5.75 LDB above Ceresco Dam.

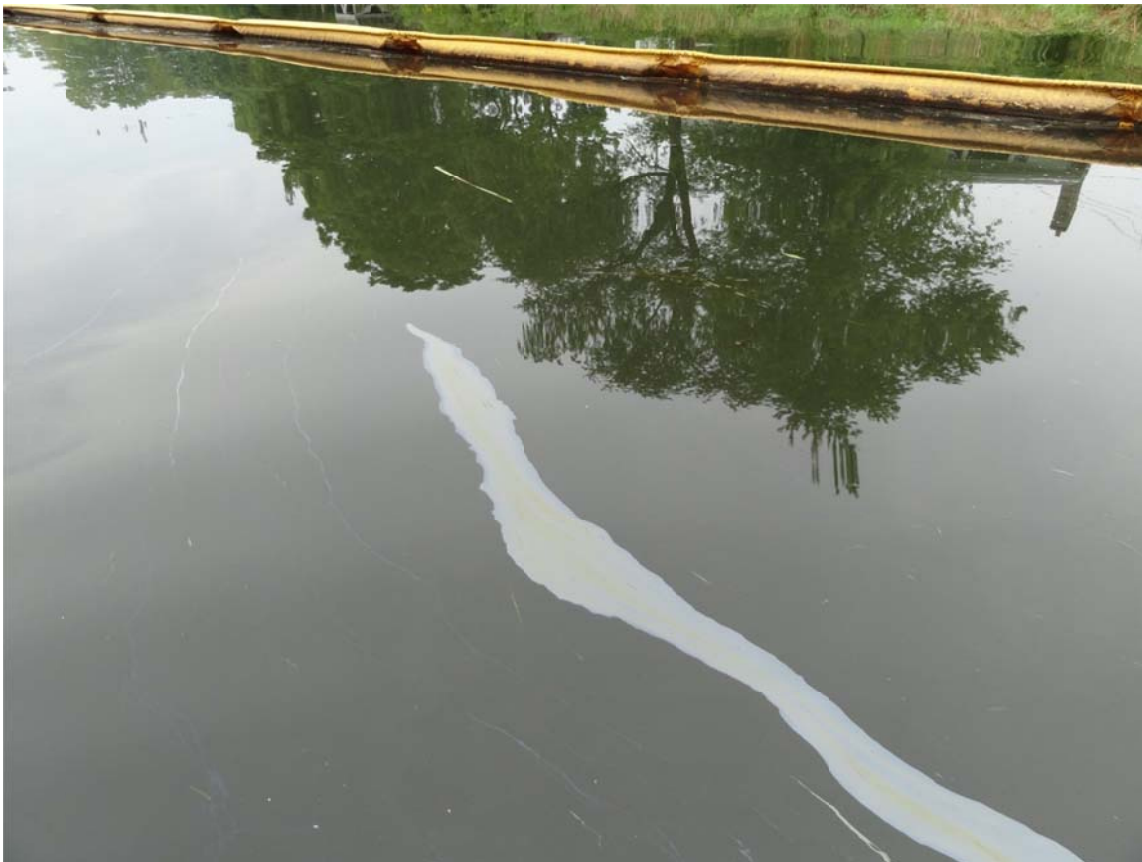
5. Sheen and tar globules observed along containment boom above Ceresco Dam.

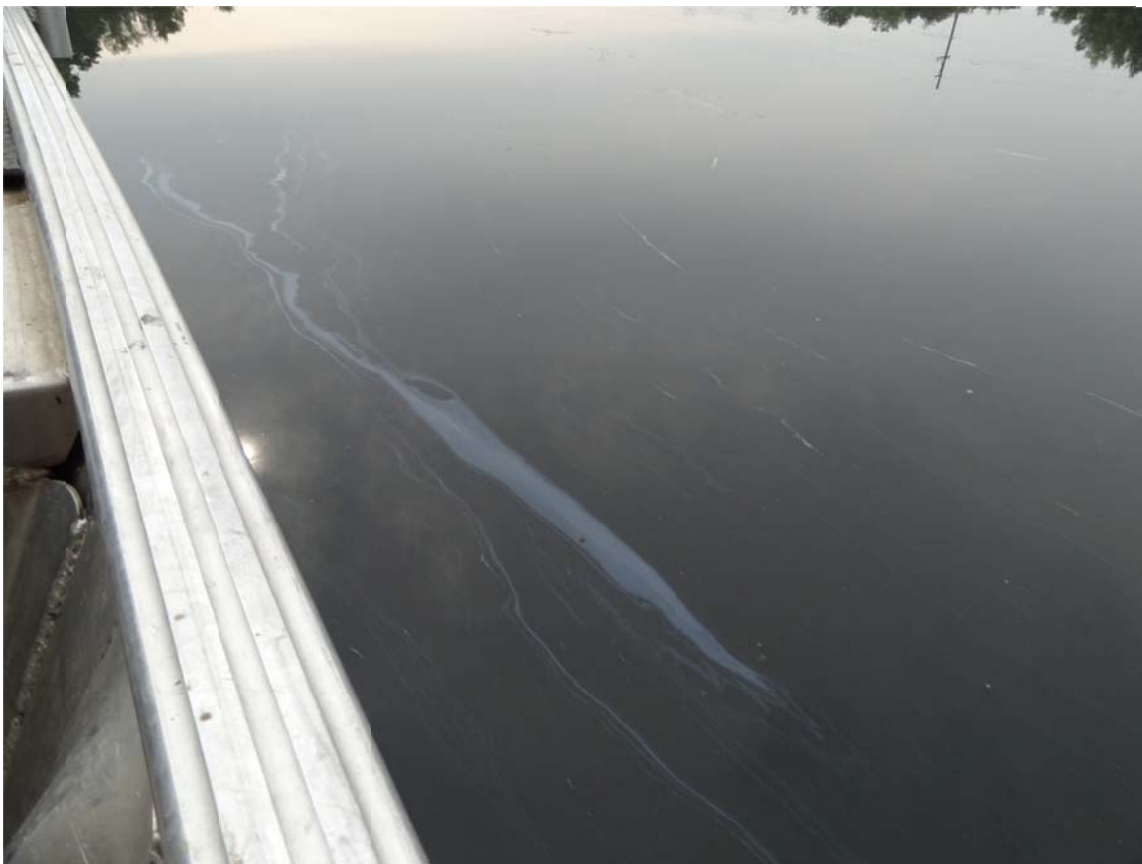
6. Sheen and tar globules observed along RDB within containment above Ceresco Dam.

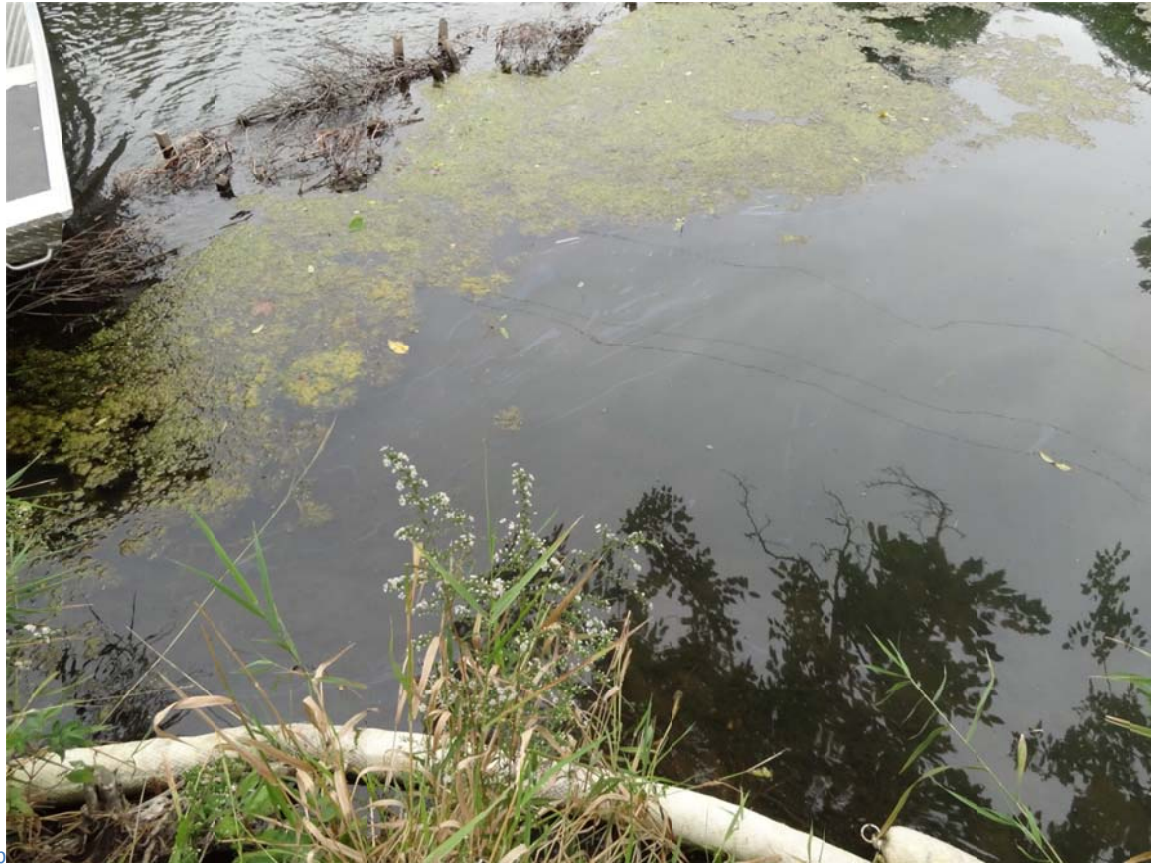
7. Sheen observed behind sediment trap at MP 10.75 LDB.

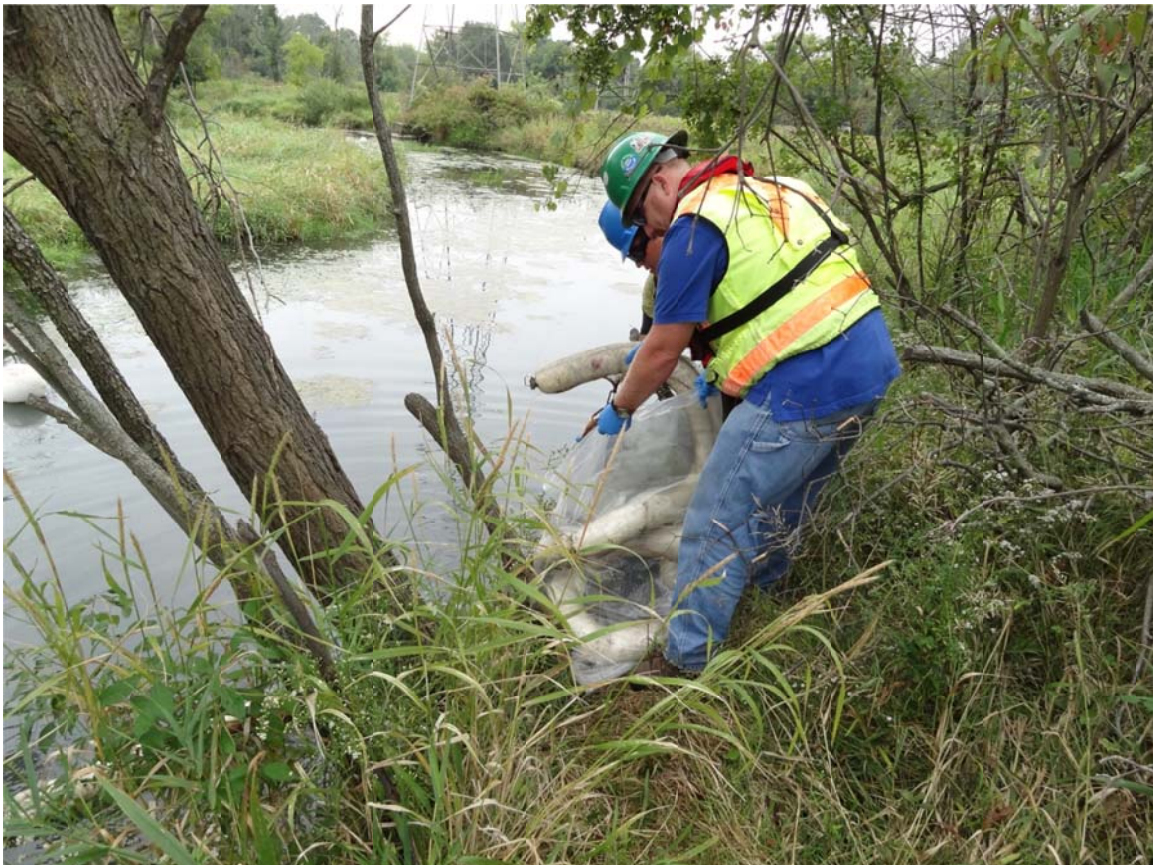
8. Crew removing containment boom along shoreline at MP 10.75 sediment trap.

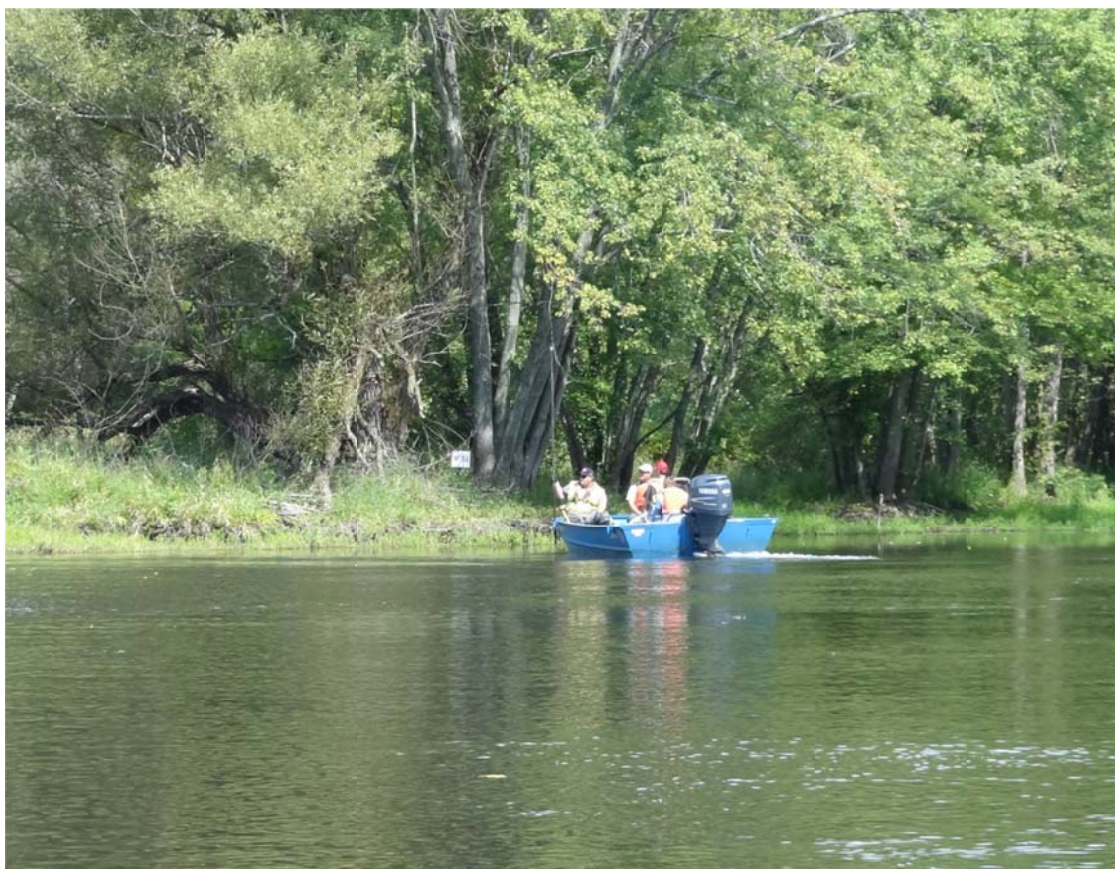
9. Sediment trap poling crew observed at MP 33.0A RDB.

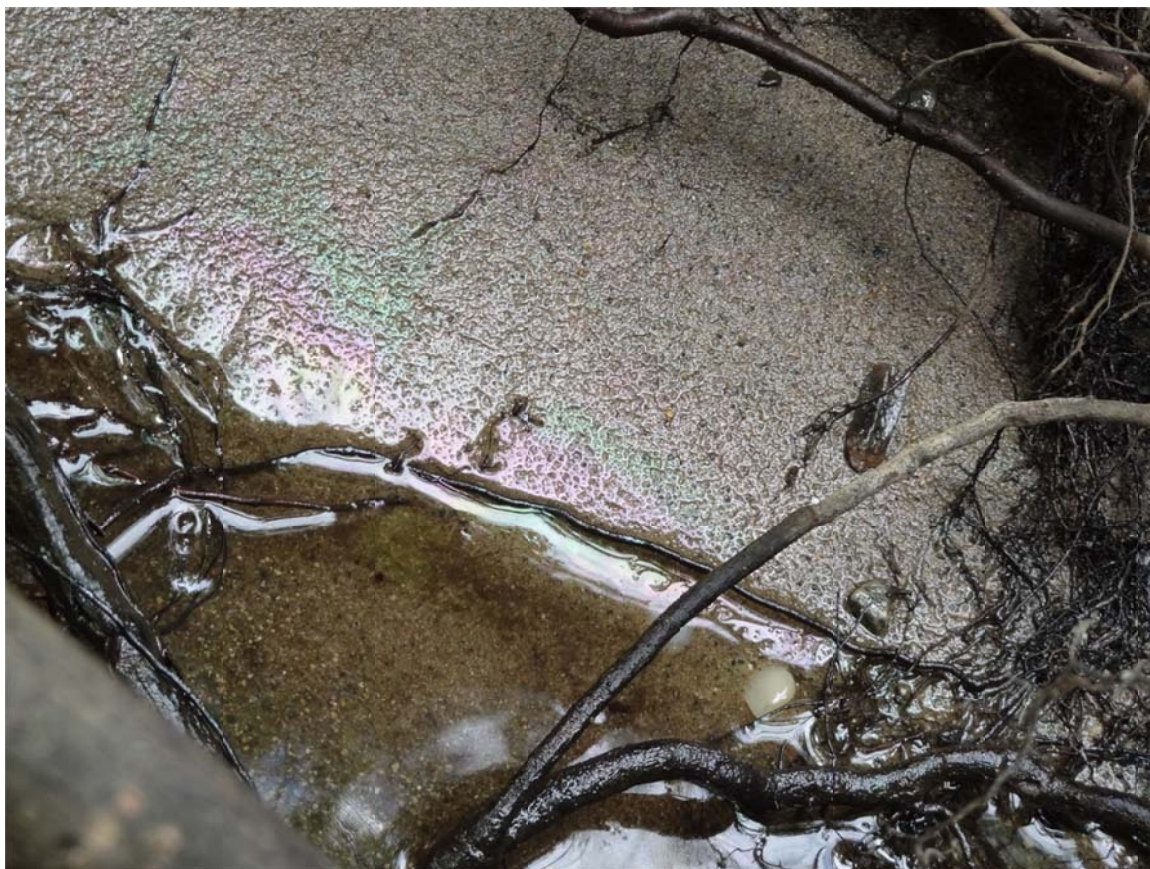
10. Sheen and petroleum odor observed at MP 33.1 RDB.

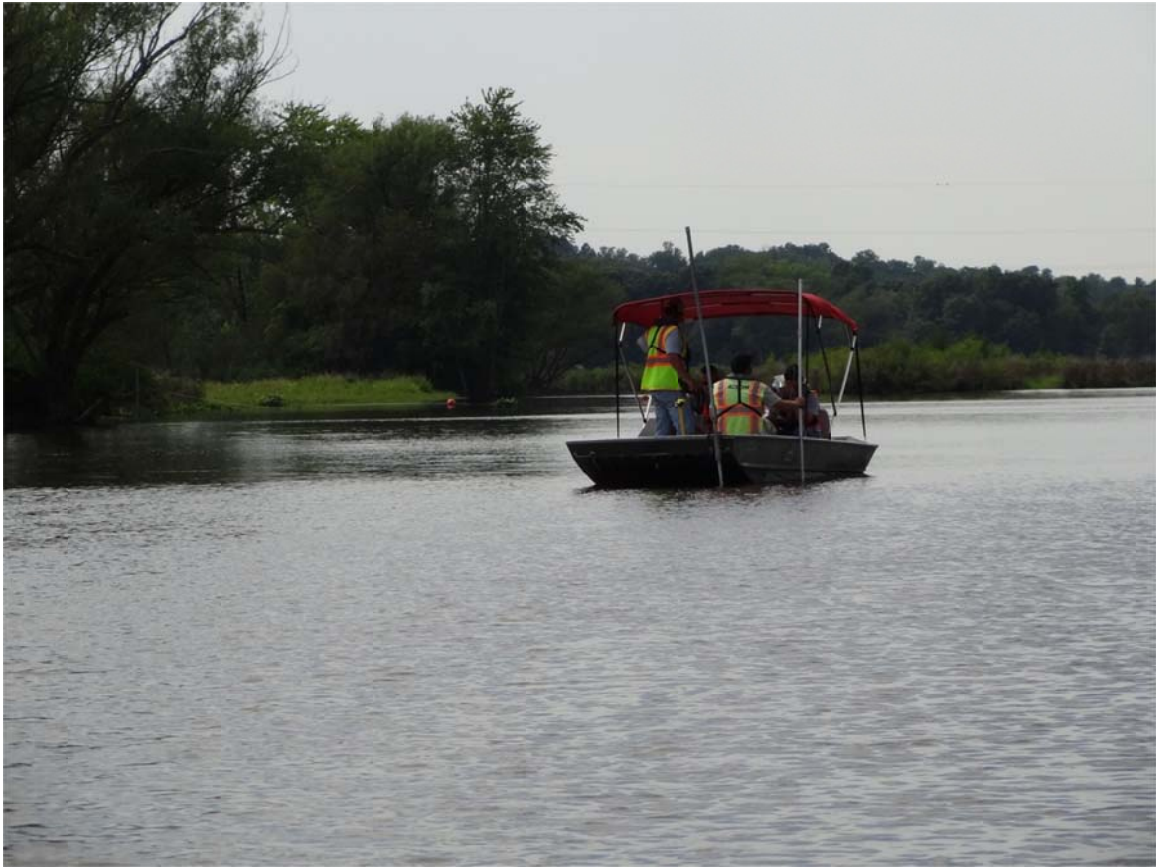
**11. Morrow Lake Delta monitoring crew operating in river channel in delta.**

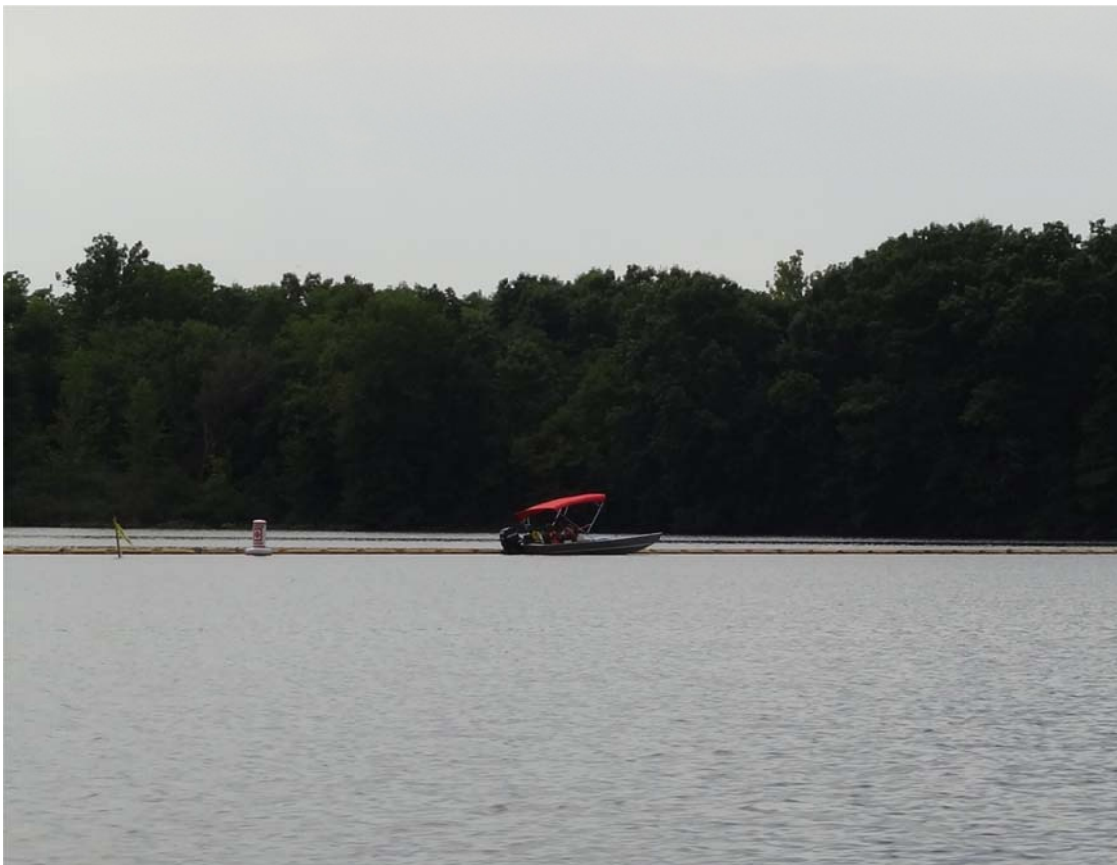
**12. Crews inspecting boom configuration C in Morrow Lake Delta.**

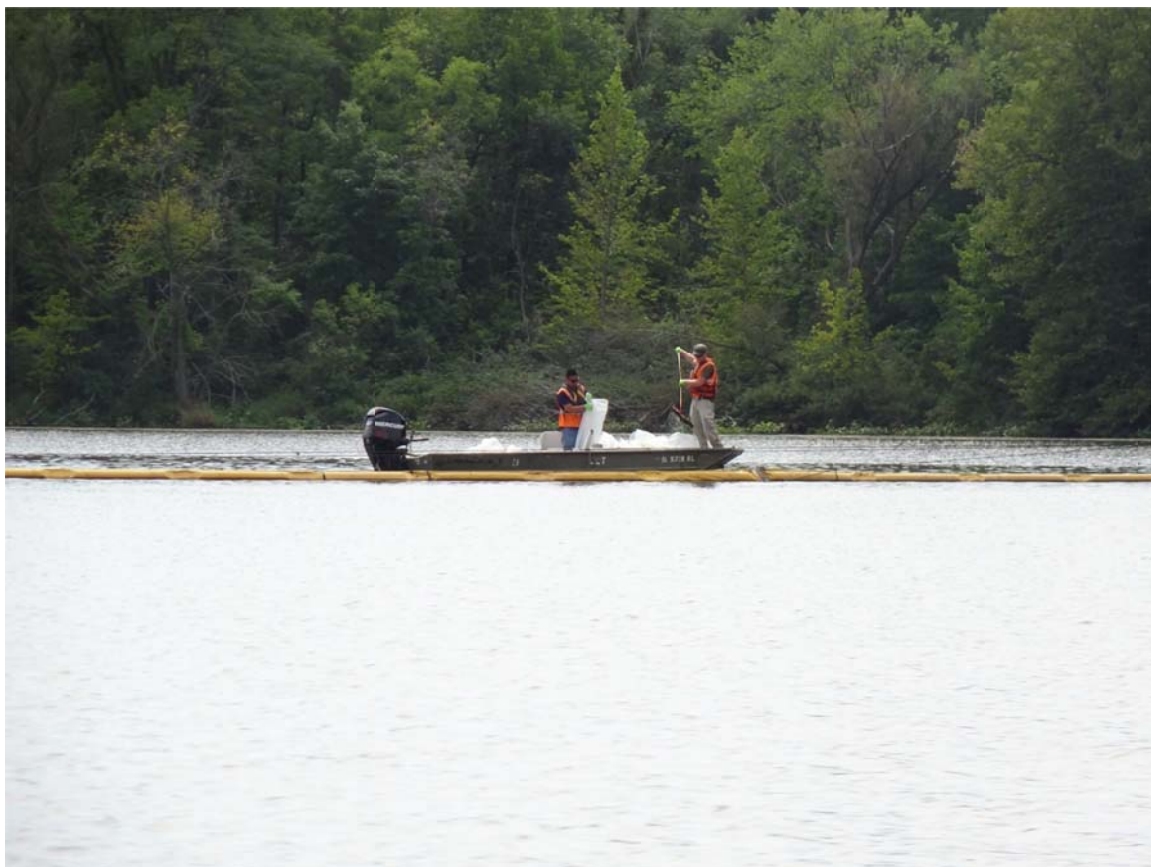
**13. Crews observed removing debris from containment configuration C in southwest portion of Morrow Lake Delta.**

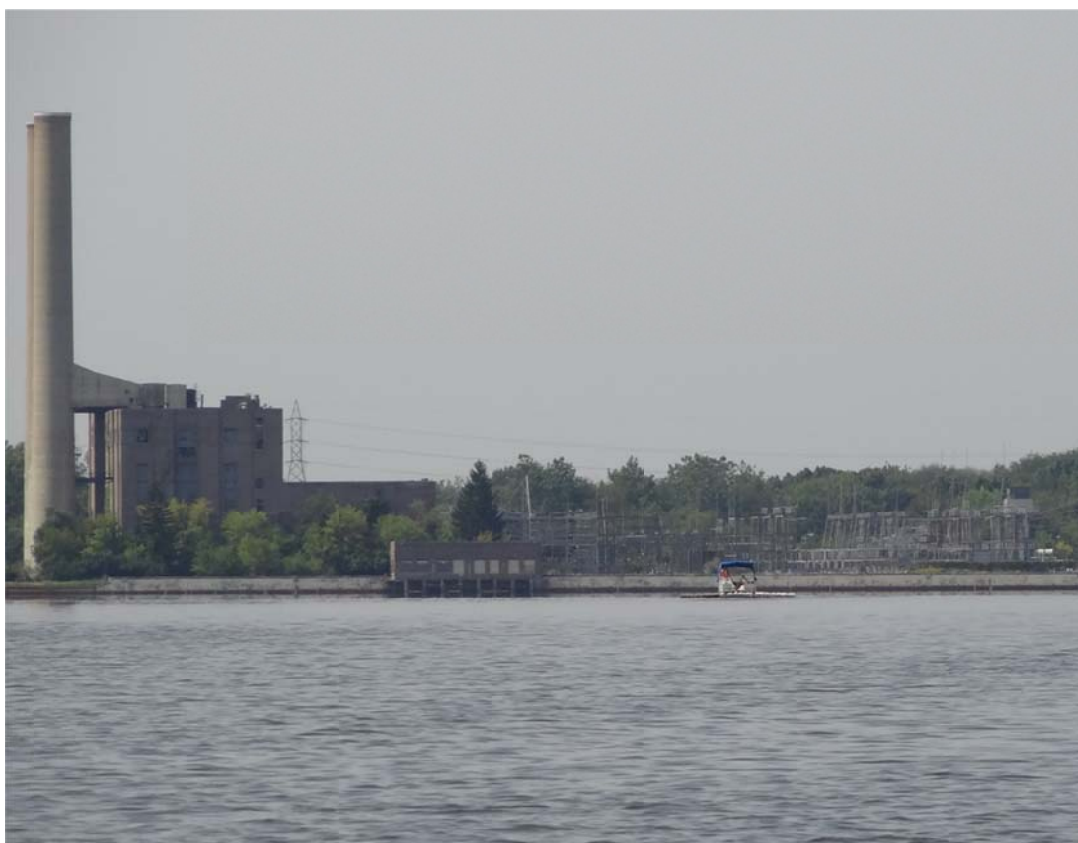
**14. Sheen sweeper pontoon boat operating in west central portion of lake.**

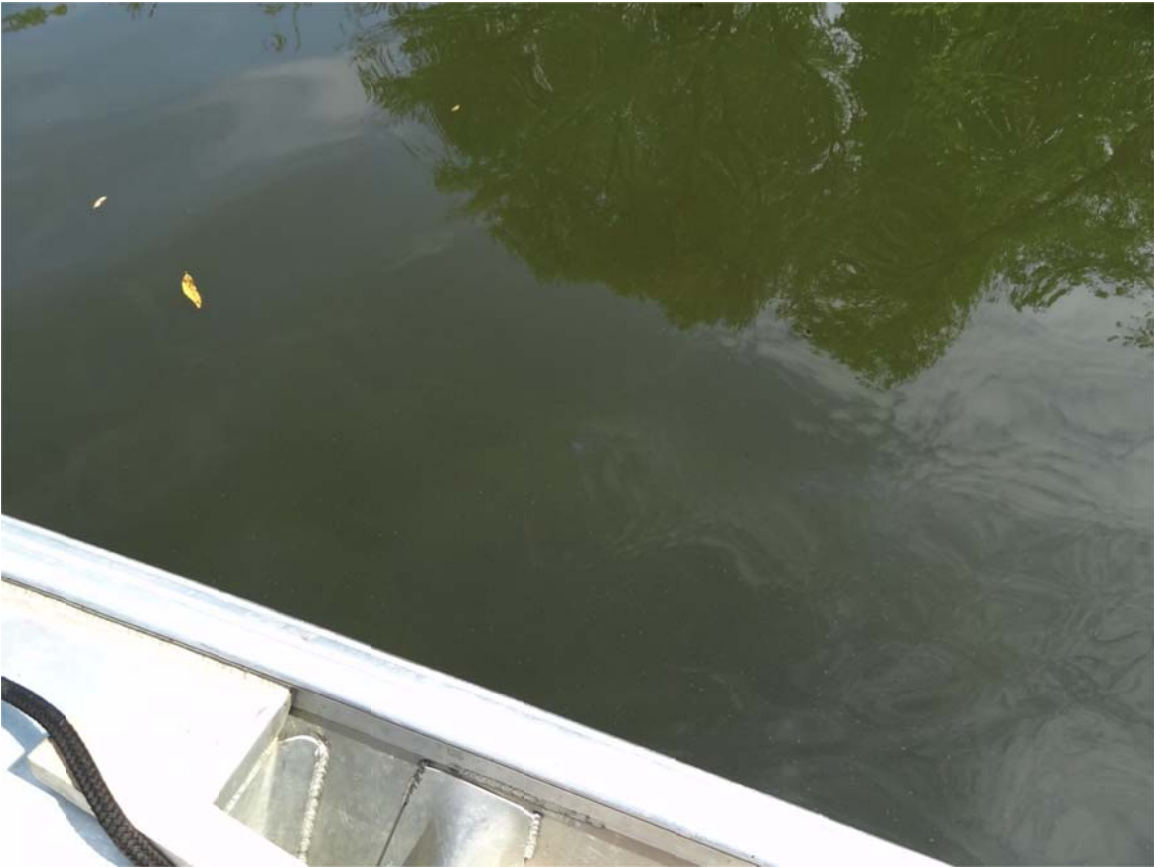
**15. Sheen observed in northern cove of Morrow Lake. Sweeper boat was notified.**

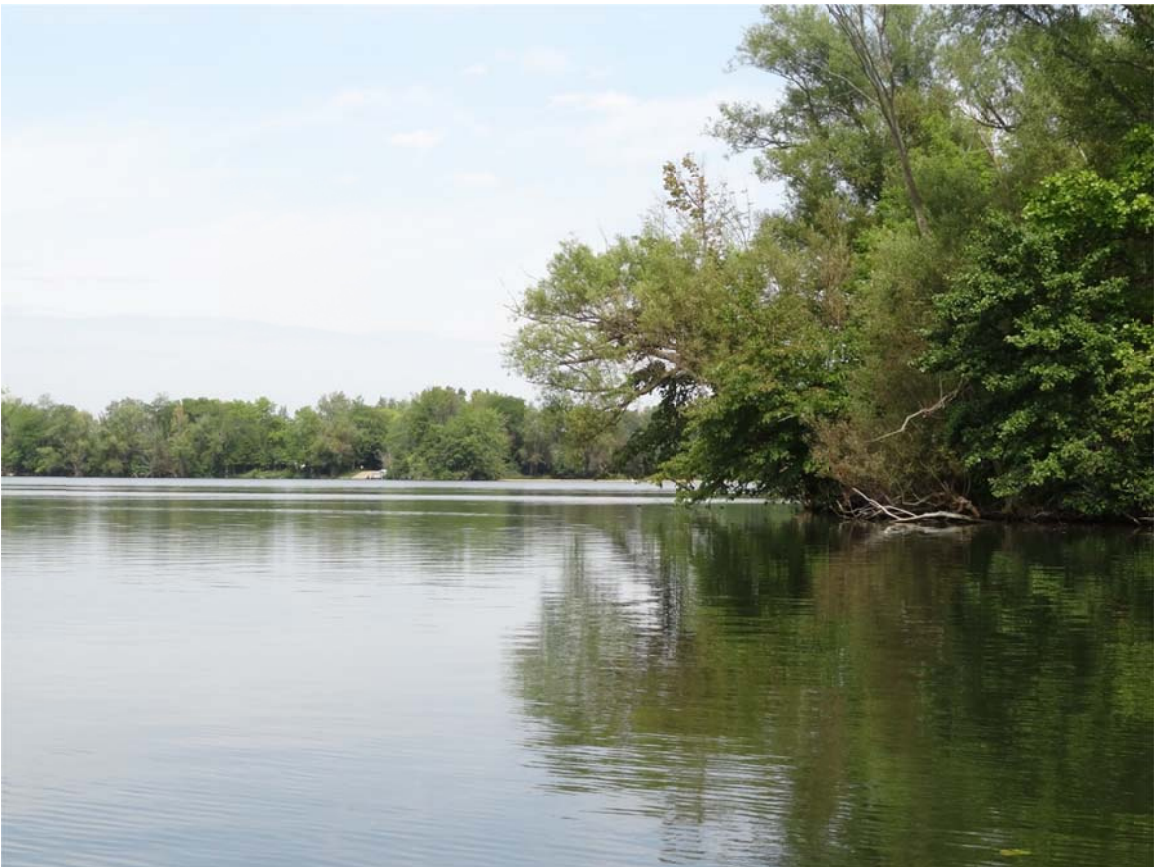
**16. South cove of Morrow Lake. Sheen observed and sweeper boat was en route.**
